Church Window Restoration Project Attachment

Job Location: Whately Congregational Church
 175 Chestnut Plain Road
 South Deerfield, MA 01373

Option 1: Insulated Glass Renovation

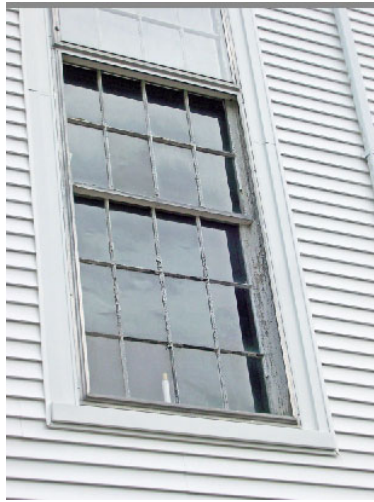
The eight windows in the sanctuary of the Whately church and the two on the front date at least to the late 19th century. They are triple-sash (12 over 8 over 12) with the top two sashes fixed in place and the bottom sash operable, and they feature very narrow muntins and frames similar to those in the auditorium at Town Hall. No glazing or painting has been done in recent memory; while the frames themselves are in good shape, the glazing is so deteriorated that the glass in many places is in imminent danger of falling out.

The storm windows are of aluminum and probably date to the 40's or 50's. They are so badly deteriorated that whole panels have come loose and at least one has fallen onto the driveway. They offer little protection of any sort.

Our plan is to remove the existing storm windows and retain the existing window frames, replacing the existing glass with double-pane glass. The restorer has indicated that the work can be done in the fall. The church plans to install storm windows to protect the frames, glazing and paint and to offer additional energy savings at an estimated cost of about \$15,000.

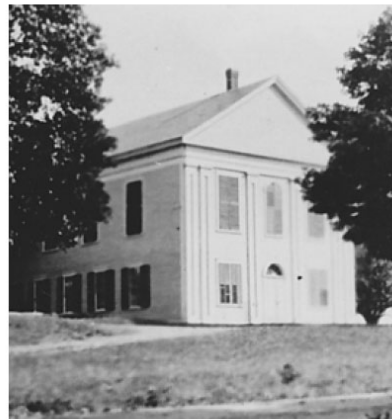
The church was built in 1843 from the same set of plans by noted area architect Isaac Damon that were used for Town Hall. Like Town Hall, the building was originally one story and it too was raised (in 1867) to accommodate a second story underneath. The similarity between the buildings is evident in these photos. Both have flushboard front exteriors with pilastered trim and the same pattern of bays on the front and side. On the interior, both have double staircases rising to high-ceilinged meeting spaces. And both are very important contributing buildings to the Whately Center National Register District.

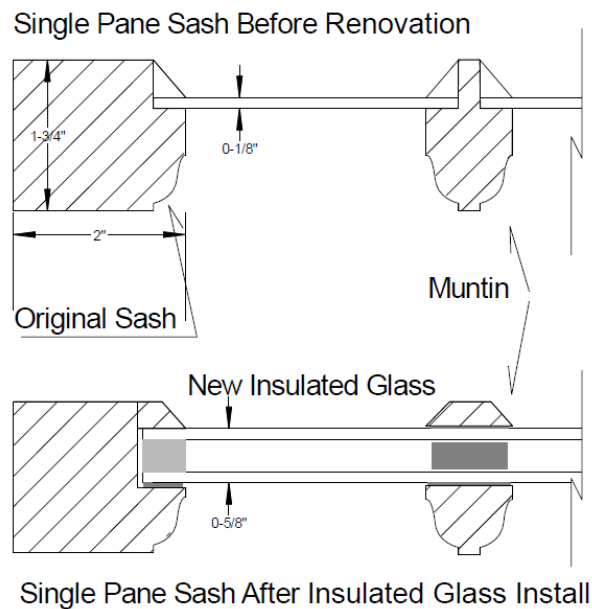
The church has contracted with Pisgah Window Solutions to do the window restoration. Their proposal is attached. The windows will be removed, and the frames routed out for insertion of the insulated glass. (See illustration) The paint will be stripped and repainted. A new block and tackle system will be installed to replace the existing sash weights and the sash weight cavities insulated.

Existing sash (and interior muntins) retained. Sashes and exterior muntins will be modified by cutting away existing putty or equivalent, increasing the width and depth of rabbet joint with Router Guide Tool in strict adherence to specifications.

Scope of Work: • Existing windows will be retained using the original sash and routing out the old single pane glazing. Pisgah Window Solutions will install and glaze one piece of thermal glass per sash. The top sash will be fixed in place while making the bottom sash operable with our block and tackle hidden balances. Original trim will be installed with kerfed felt weather-stripping; the bottom sash rails will be kerfed and relieved for silicone bulb weather-stripping and properly fit to opening as to eliminate any exterior drafts.
